Case Study

Final Stage Blade Modification Extending Life Cycle

Sulzer Turbo Services Indonesia was contracted by an international nickel production company located in South Sulawesi to perform a complete inspection and repair on their 28 MW steam turbine rotor. The unit was reported as having excessive vibration. Further field inspections found that one of last stage blades and the damping wire were broken. The customer requested Sulzer Turbo Services Indonesia to investigate the root cause of the failure and modify the blade to extend the life cycle.

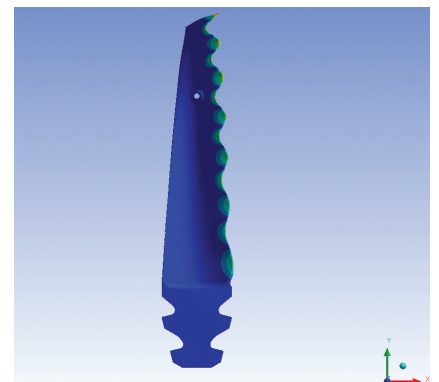
mined two crack initiations located at the blade hole for damping wire and trailing edge. To support the evidences found on metallurgical analysis, stress analysis was then performed. This determined the stress level on the blade and damping wire due to centrifugal force. This analysis was conducted using finite element software. The blade was scanned and measured using portable CMM (Coordinate Measuring Machines) to define the blade profile prior to modeling in finite element program. The result indicated the maximum stress of the airfoil at blade hole was beyond the yield strength of the blade material.

The stress level on the damping wire was analyzed using line elements. A certain section of the wire was modeled and symmetrical constraints were applied to represent the actual condition of the wire. The analysis result showed that the damping wire has a safety factor of 1.25. This safety factor value is marginal and can lead to failure. The damping wire strength

may have been reduced by corrosion, galling, and erosion. This would lower the safety factor significantly.

Finite element analysis of the blade.

The final redesign came to damping wire size enlargement and adding reinforcement at blade hole. The finite element analysis of the modified blades and new size of damping wire was conducted to see how significant the stress level would be reduced. The analysis result indicated the stress level of the airfoil at the blade hole for damping wire decreased by 38% and the new size of the damping wire had 34% of the stress level of the original one. The natural frequency analysis also indicated no significant change in natural frequencies.

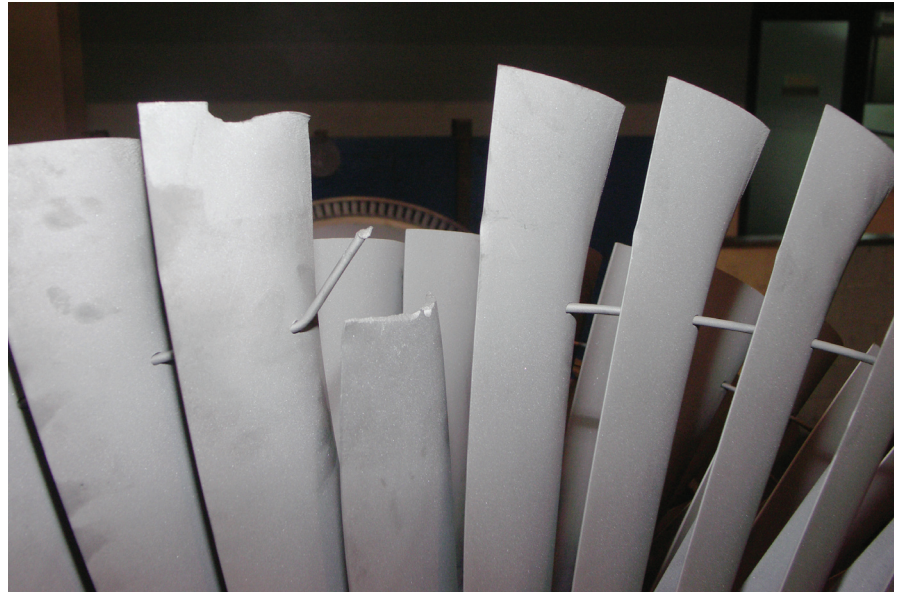
Incoming condition of the last stage blades.

sis results, it was concluded that the root cause of the failure was the low safety factor of the damping wire. Once the damping wire failed, the blades were no longer damped and the amplitude of resonance became high enough to start initiating the crack at the trailing edge. A proposal was made to enlarge the damping wire size and blade redesign to shift

The final design of modified blade was then forwarded to the blade manufacturer for blades production. The new blades were then moment weighed and installed in the unit. The unit is now running at full capacity without any problems.

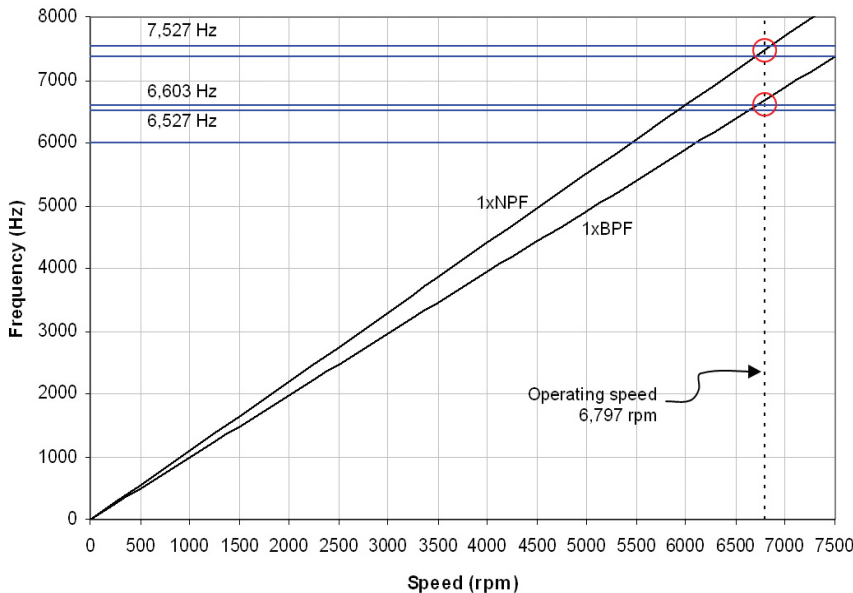
The result of both tests on the blades showed that there is no significant difference with the numerical analysis result by finite element method. This indicates that the natural frequencies obtained can be used for further analysis. The natural frequencies of the analysis were then plotted on Campbell diagrams to identify significant resonance points. Campbell diagrams depict turbine speed on the horizontal axis and frequency on the vertical axis. The natural frequencies and the frequencies of exciting forces were plotted. The coincidence of natural frequencies with the exciting forces is used as the definition of resonance. The data was next analyzed at blade pass frequency (BPF) and nozzle pass frequency (NPF). Some intersections were noted.

Campbell Diagram.
